JOB TITLE:
St Mary Hitchin

STATUS:
Proposed

DRWG. TITLE:
Boiler House Plans & Elevations

DRWG. NO.: 2204/50-P

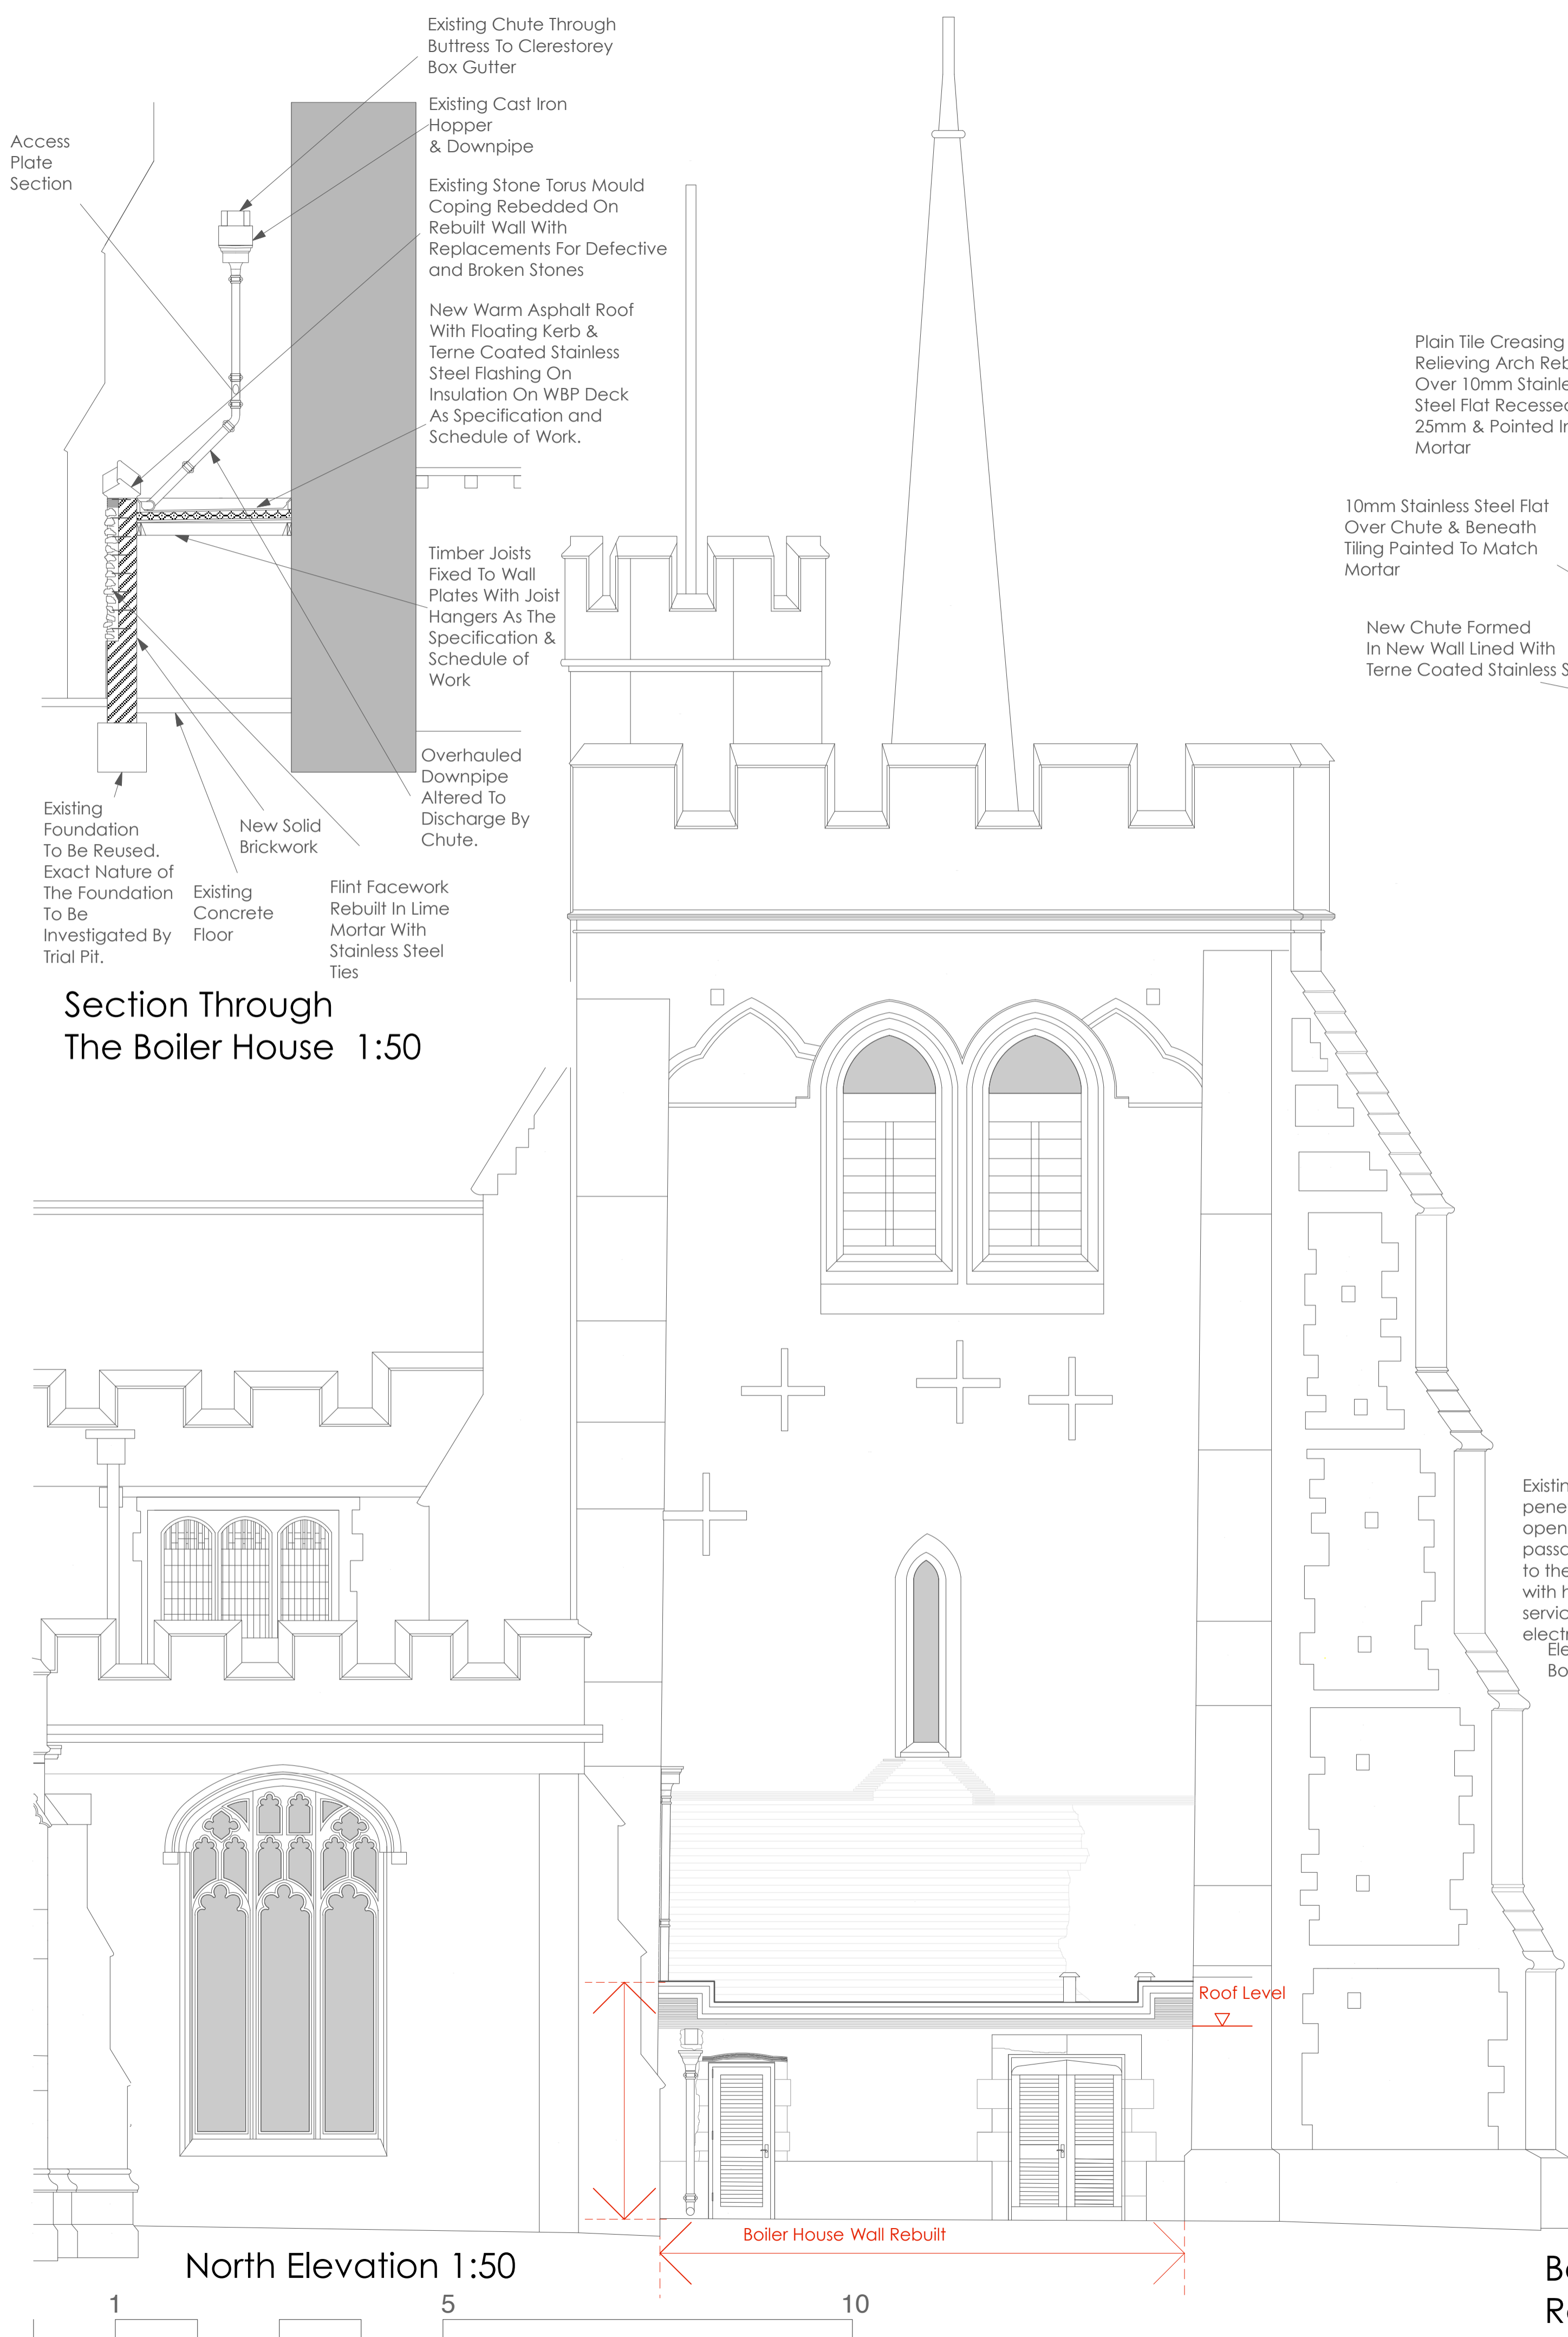
Access Plate Section

Existing Chute Through Buttress To Clerestory Box Gutter

Existing Cast Iron Hopper & Downpipe

Existing Stone Torus Mould Coping Rebedded On Rebuilt Wall With Replacements For Defective and Broken Stones

New Warm Asphalt Roof With Floating Kerb & Terne Coated Stainless Steel Flashing On Insulation On WBP Deck As Specification and Schedule of Work.

Timber Joists Fixed To Wall Plates With Joist Hangers As The Specification & Schedule of Work

Overhauled Downpipe Altered To Discharge By Chute.

Existing Foundation To Be Reused. Exact Nature of The Foundation To Be Investigated By Trial Pit.

New Solid Brickwork

Existing Concrete Floor

Flint Facework Rebuilt In Lime Mortar With Stainless Steel Ties
